The Coastguard Station (MBW 34) at Medmerry, near Selsey, West Sussex

Peter Murphy with contributions from
Hugh Fiske, Mike Kallaway, James Kenny and Peter King
January 2024

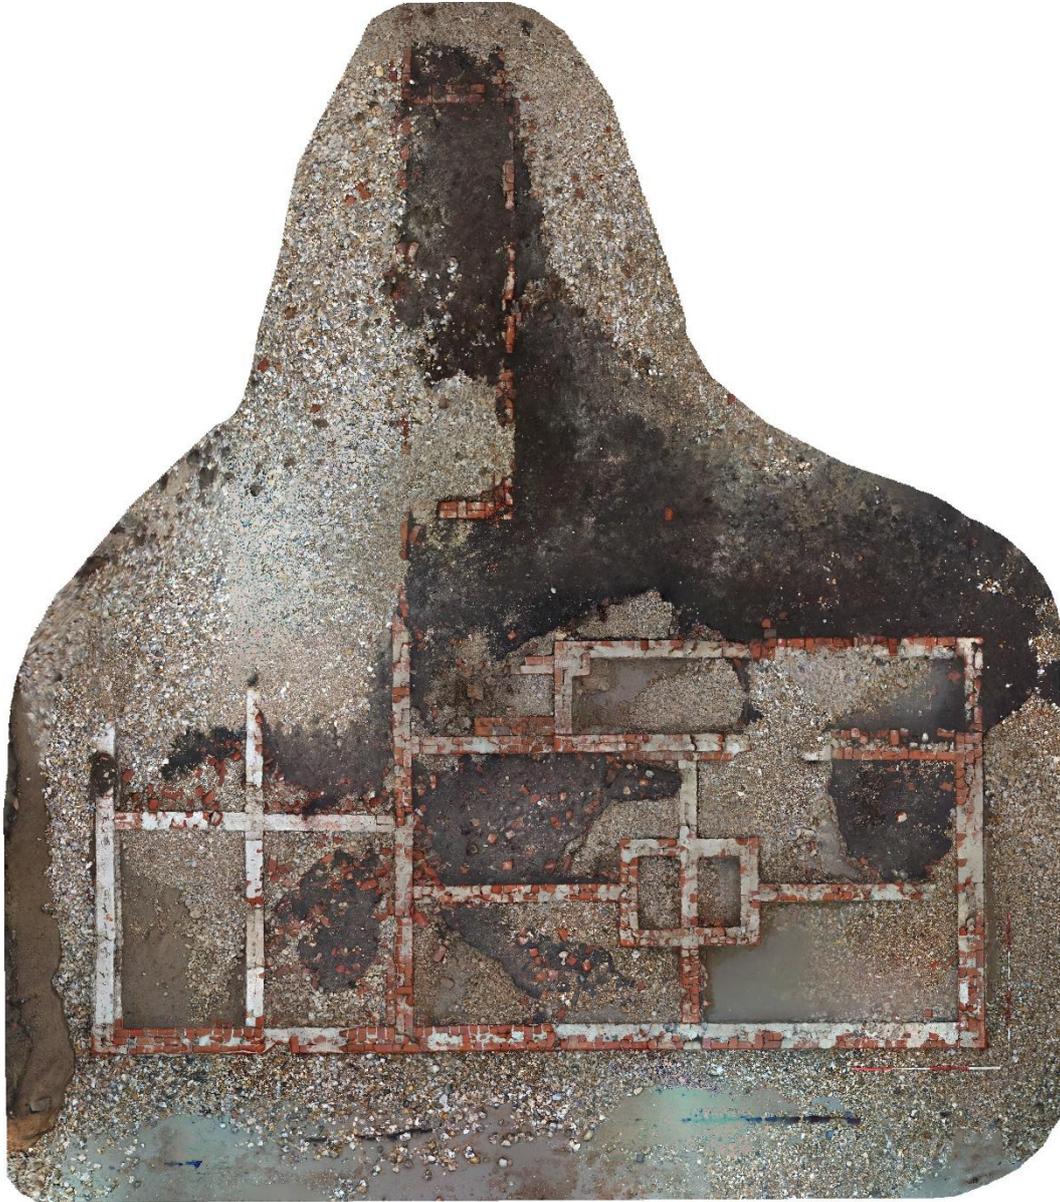
Fig 2 Ortho-rectified plan of the southern wing of the building, and part of the central range (still largely under beach shingle), based on survey on 25th January 2020. North at top, approximately. Metre scale to bottom right. Image by Hugh Fiske.

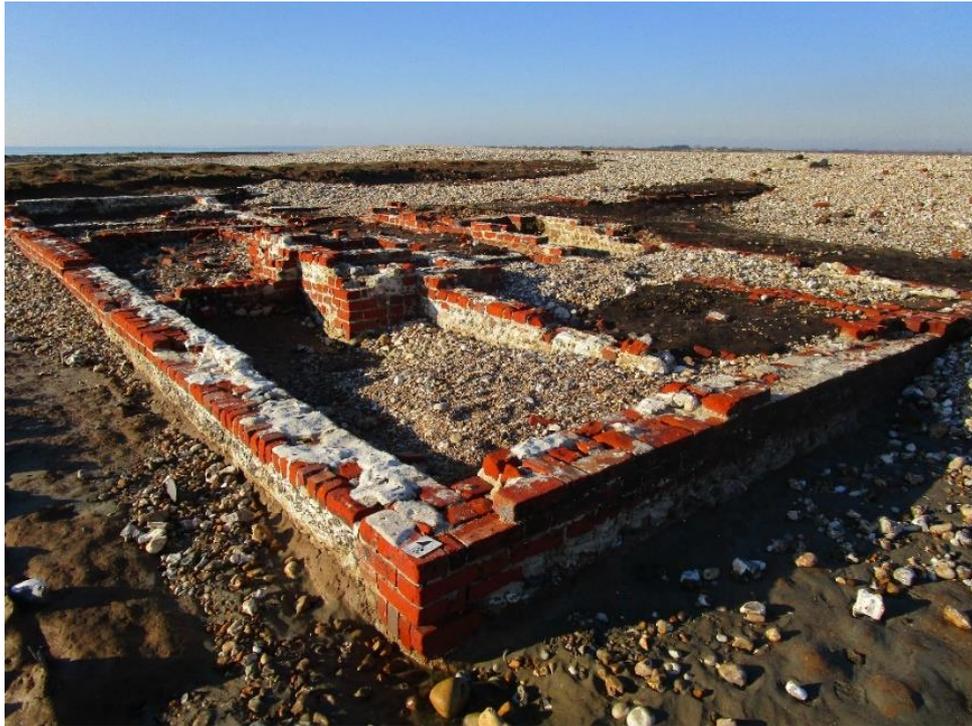
The foundations comprised up to five courses of unfrosted red brick with lime mortar on a flint rubble and lime mortar base (Figs 4-5). They had been built on a firm base of Tertiary sediments, on which a very dark grey-brown surface including charcoal, clinker and soot (a disturbed palaeosol) had developed. The outer walls were approximately three bricks thick, two bricks thick for internal walls, though bricklaying was irregular at this low level. Overall dimensions of the south wing were 10.54 x 5.35m. The eastern part of this wing was subdivided into four small rooms, with an outer flanking corridor to the north, and with four further rooms to the west. There was a central setting of two small brick features resembling fire-places supporting a chimney, though these showed no sign of burning at this low level. The central range of the building to the north was exposed over a distance of 9.7m, with a porch and threshold facing to the east. On the south side a pathway, 1m wide and parallel with the wall, was delineated by vertically placed slates (Figs 2 & 5). A French drain, cobbled surface and brick threshold were also recorded (Fig. 6).

Fig 4 Foundations of the southern wing of the building as seen on 21st January 2020, looking NW. Photo by Peter Murphy

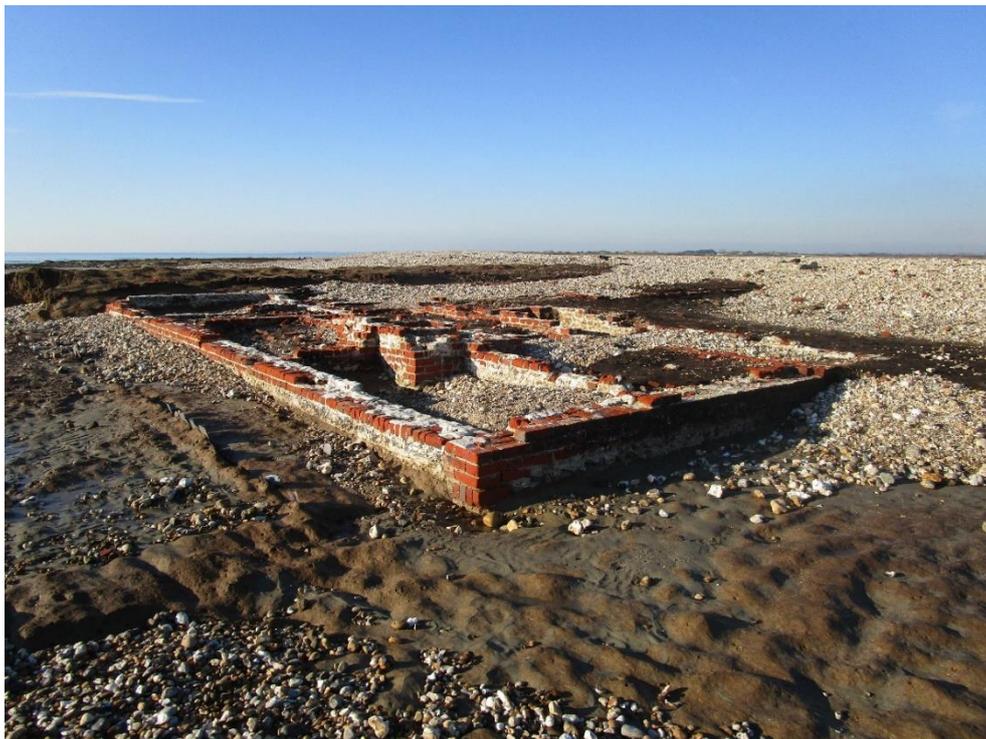
Fig 5 Wider view of the building, showing vertically-placed slates alongside to south, defining path, and palaeosol. 21st January 2020. Photo by Peter Murphy.

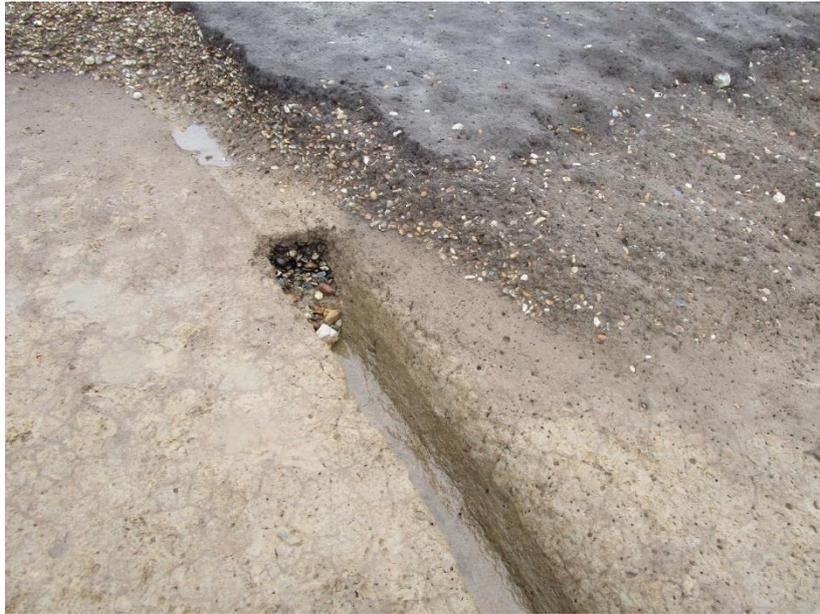
Fig 6 French drain. 21st January 2020. Photo by Peter Murphy

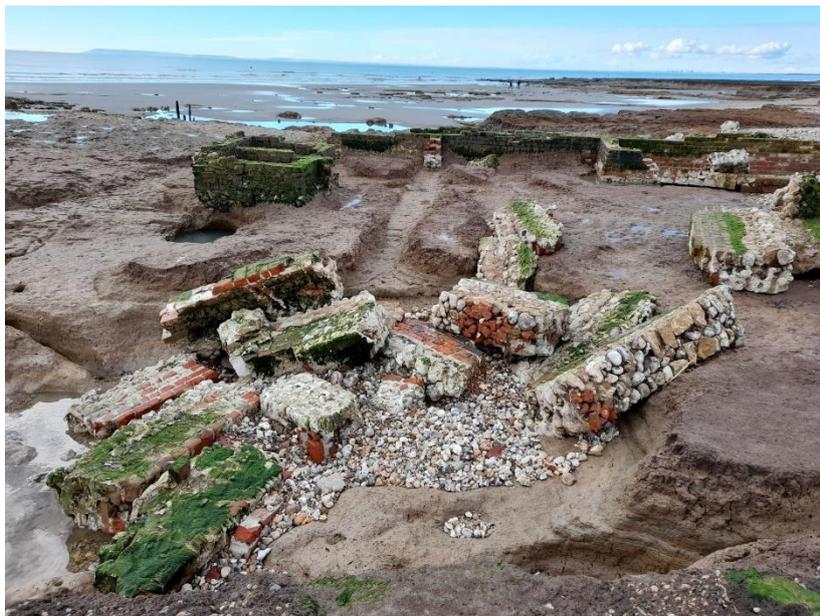
Further fieldwork was difficult during the subsequent Covid-19 restrictions, but continued and repeated observation by Peter King showed that marine erosion had reduced the southern part of the building to a heap of rubble by 7th February 2021. By early January 2022, shingle recession had exposed the north wing, which was actively eroding on 1st March 2022.

Fig 7 The southern part of the building, destroyed by marine erosion, 7th February 2021.
Photo by Peter King.

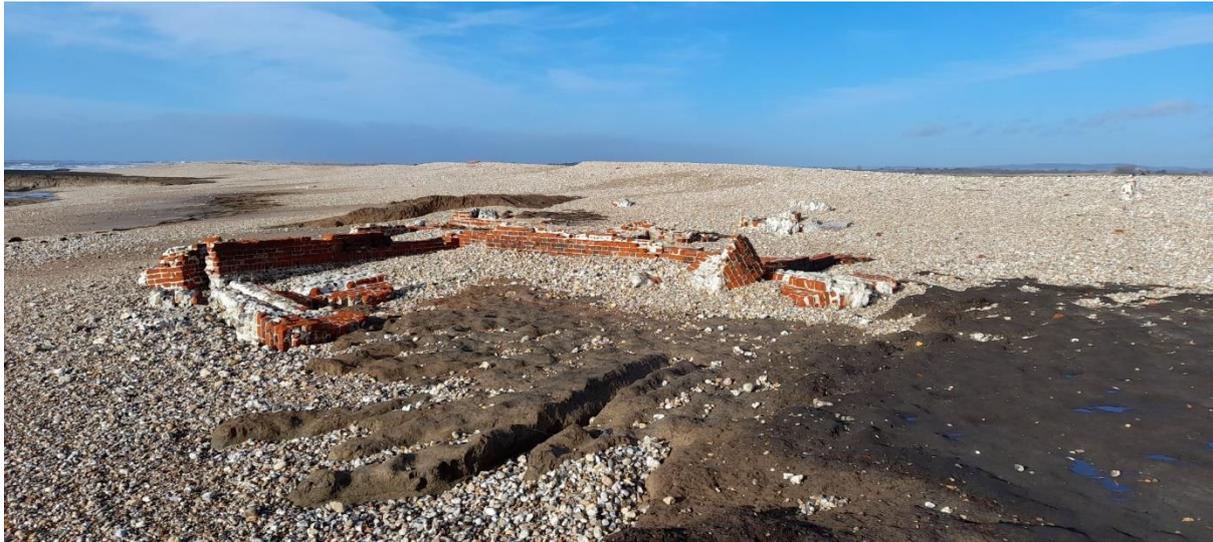
On 9th January 2022 Peter King first photographed the northern wing (Fig 8). By 1st March 2022 this was actively eroding, but enough survived to show that it was symmetrical with the southern wing, comprising a mirror-image set of four rooms grouped around a four-way fireplace and a corridor to the south. Detailed planning was impractical but a series of photographs showing the progressive exposure and destruction of the northern wing of the building is given in Figs 8-9. Leading from the NE corner of the northern wing a gravelled path, heading NE, delineated by sandstone boulders, had been differentially eroded. The gravel had been largely removed by marine erosion, so it had a ditch-like appearance.

Fig 8 The northern wing of the building, exposed in a semi-ruinous state, 9th January 2022.
Photo by Peter King.

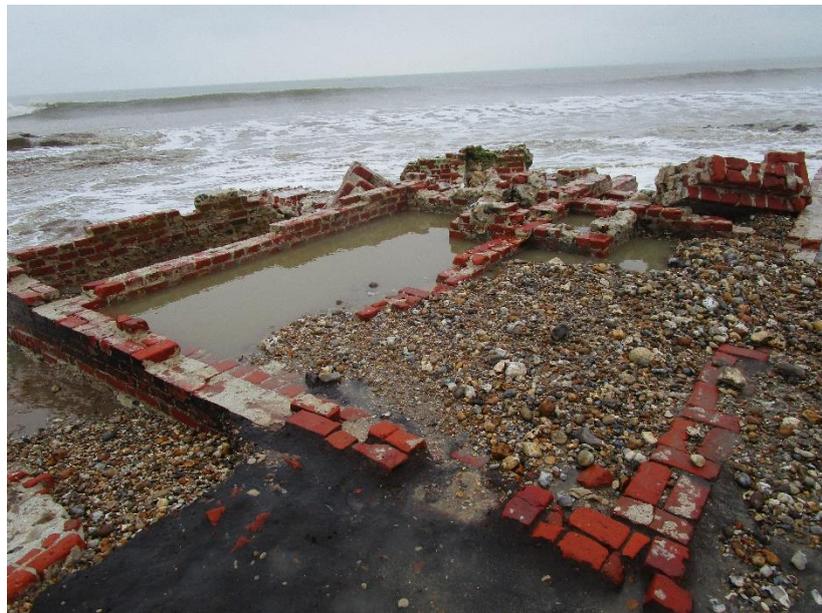
Fig 9 The north wing actively eroding, 1st March 2022. Photo by Peter Murphy.

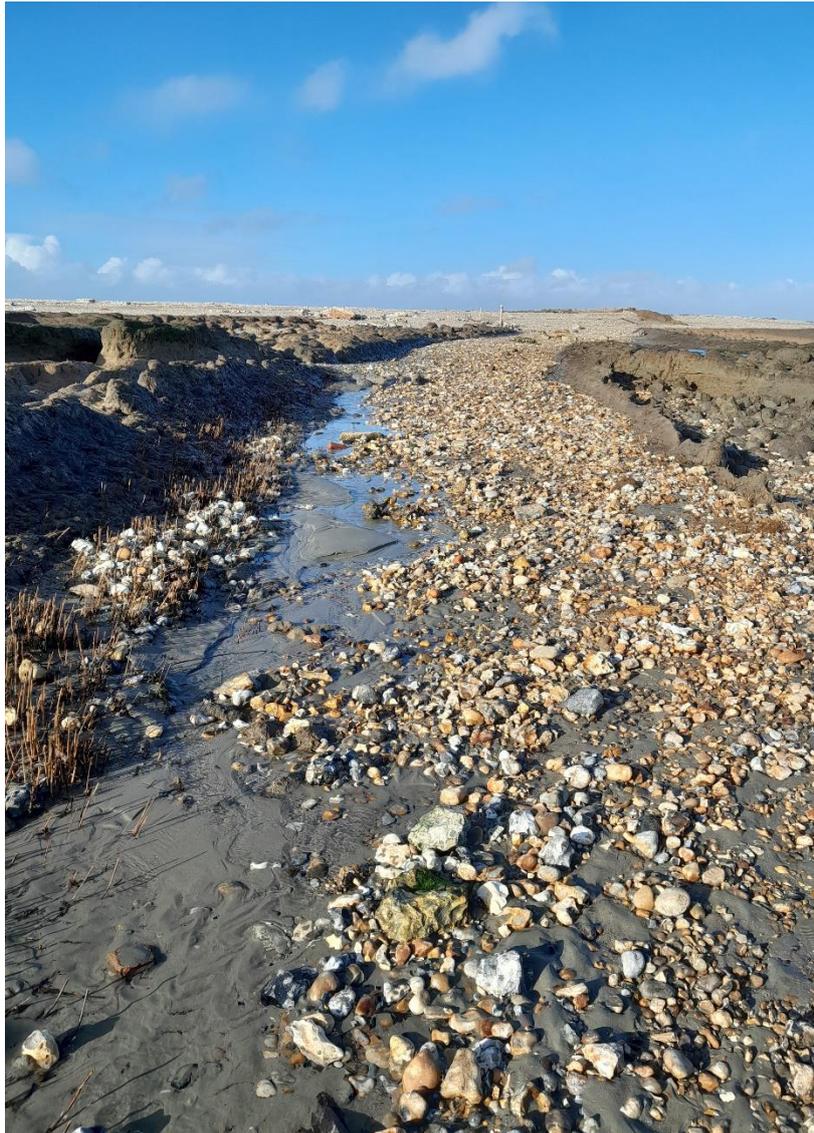
In a subsequent visit in March 2023 Mike Kallaway observed remnants of a channel running roughly N-S and slightly to the E of the Coastguard Station (see Fig 10). GPS readings taken along the edges of the channel confirmed that it was the one shown on the map in Fig 3.

Fig 10 View of remains of channel looking North, remnants of Coastguard station are visible just below the skyline. Photo Mike Kallaway
