Medmerry Managed Realignment - Monitoring Update: Summer 2016

Report – ENVIMSE100291

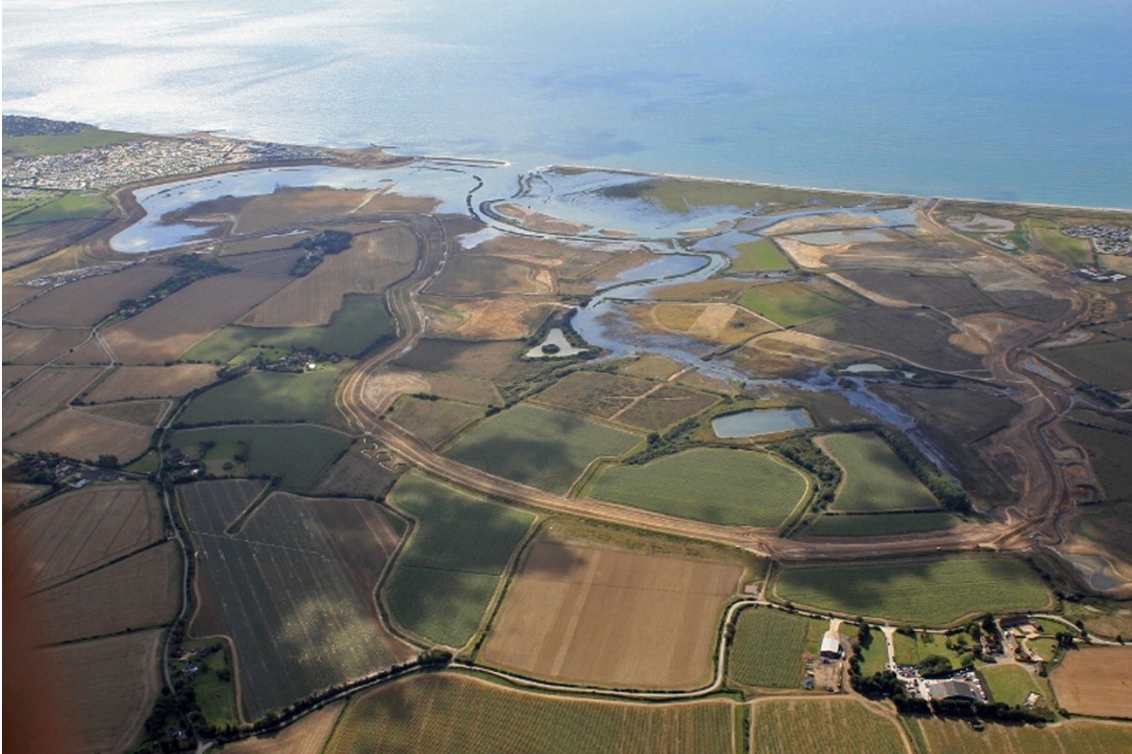
Figure 1.1: Aerial photo of Medmerry looking south, 19 September 2013 (Environment Agency)

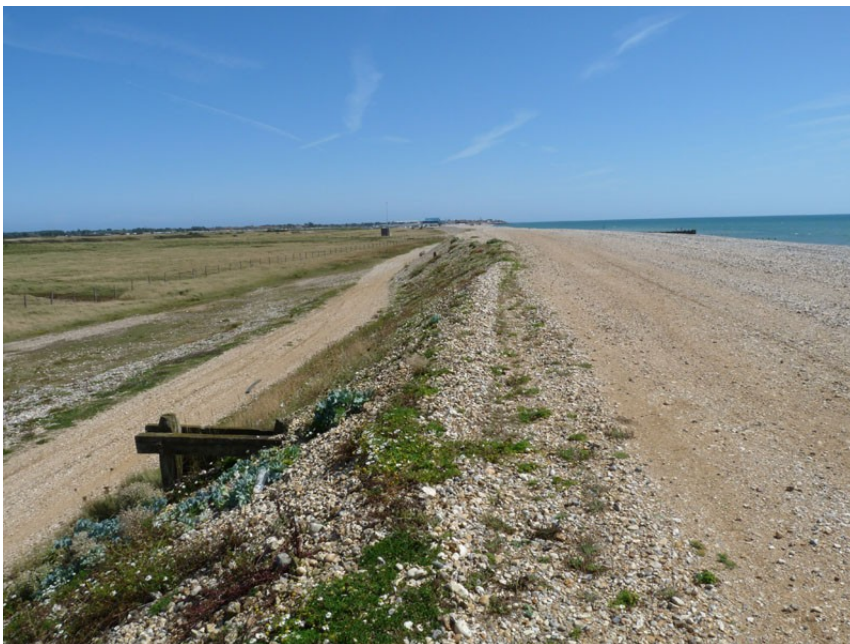
Figure 2.1: Medmerry beach looking SE, 3 August 2009 (Adrian Thomas)

Before Medmerry was breached, the shingle barrier beach between Bunn Leisure and Bracklesham was maintained by bulldozer as a high bank, steep-sided on both the seaward and landward sides (Fig 2.1). The shingle included imported material to bolster the bank, and there was evidence that there was a rudimentary 'hoggin' (a mix of clay, gravel and granite dust or sand) within the bank that historically would have been used to try and bind it together. There was also a series of wooden groynes embedded within the bank and projecting either side to slow the littoral drift of shingle towards Bracklesham.

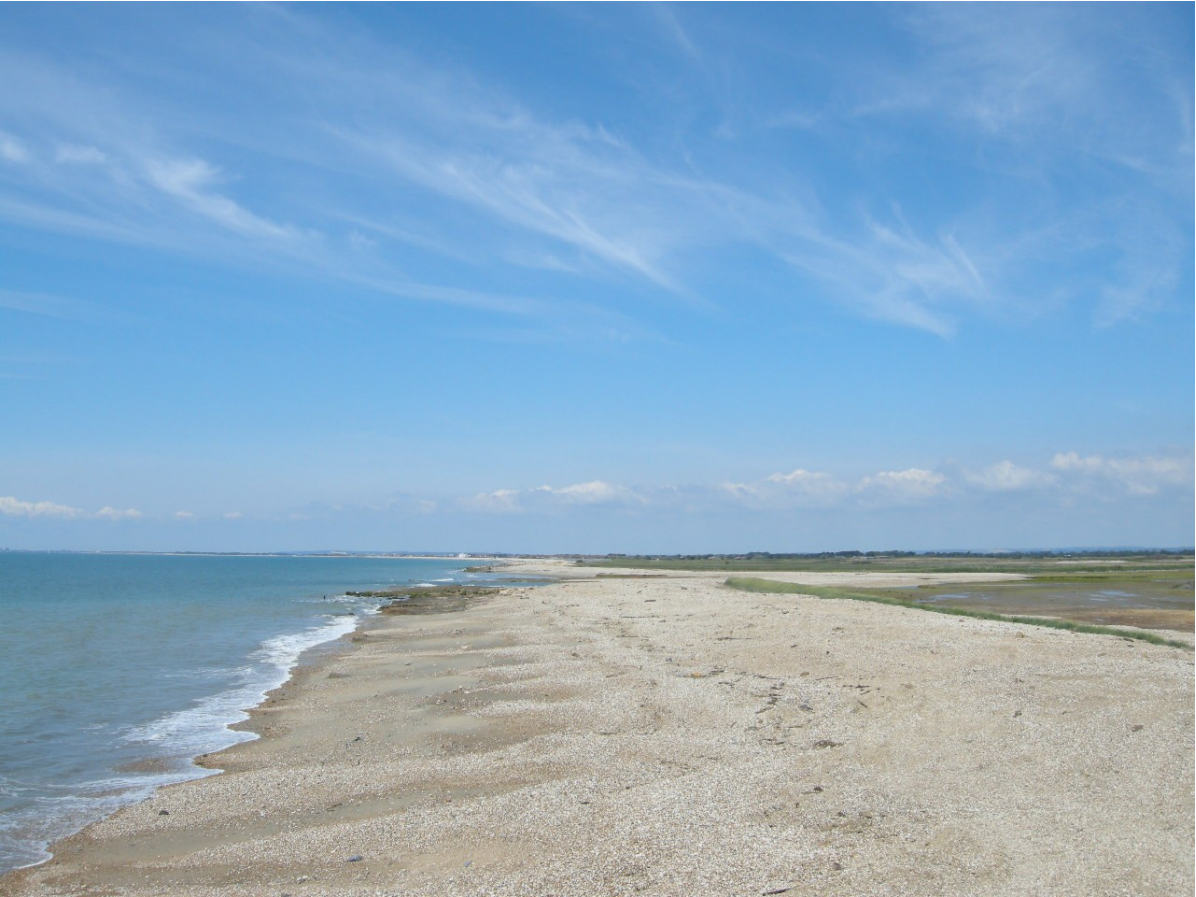
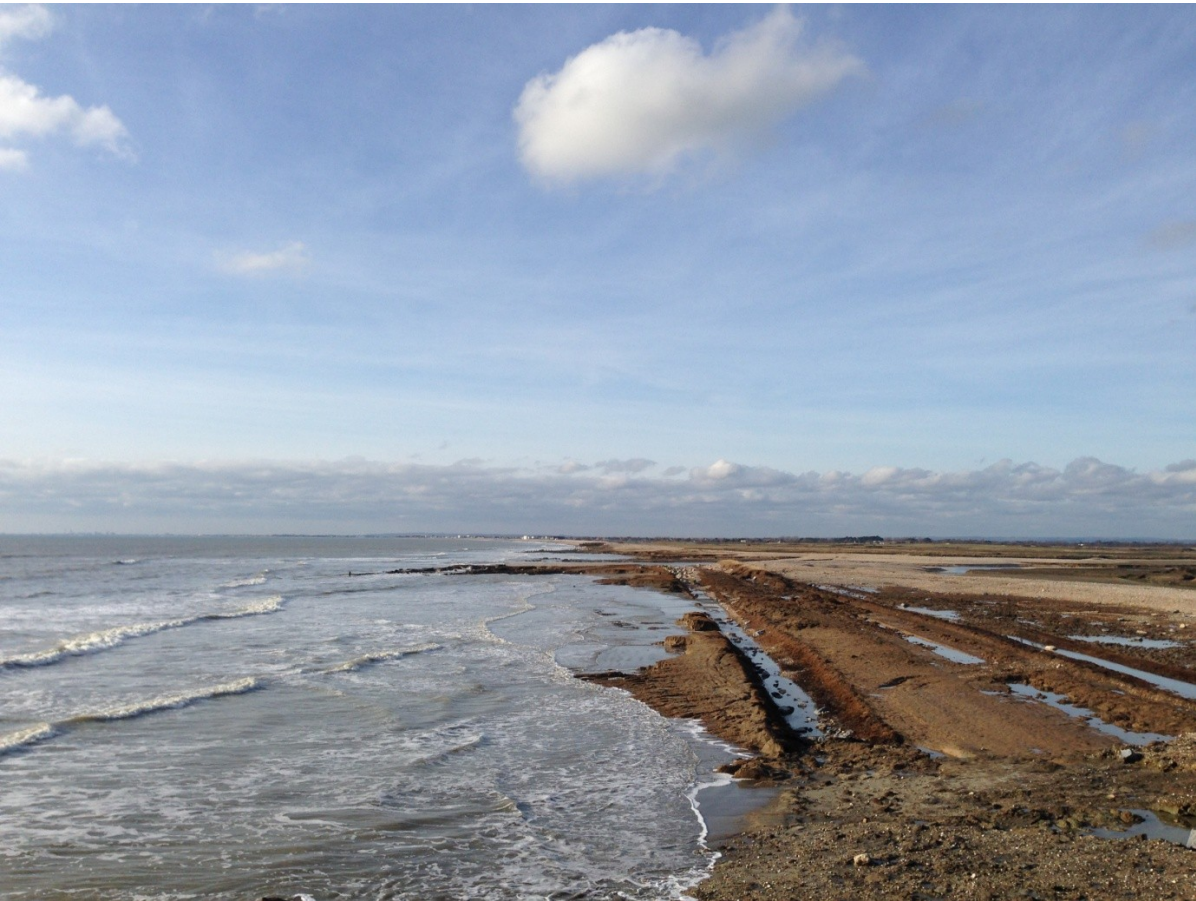
Figures 2.7 & 2.8: East Beach from the same vantage point looking NW, July 2014 & Feb 2016

Much of the original movement of shingle took place in the repeated storms of winter 2013/14, but spring tides and storm conditions continue to remodel the shingle, in a way that was predicted but perhaps at a pace quicker than originally anticipated. It is also expected that there are several more years of considerable 'rolling back' before Medmerry's beach achieves some kind stability.

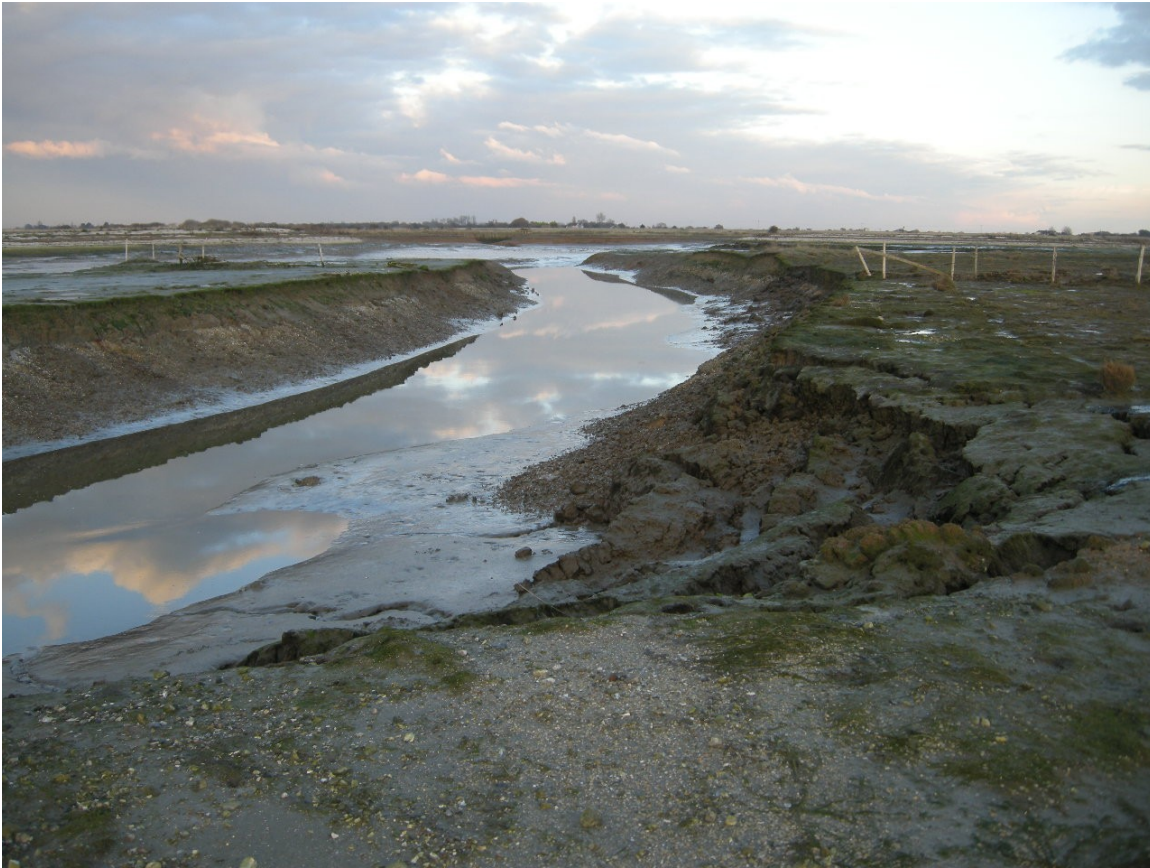
Figure 4.3: Developing saltmarsh, 18 November 2014 (Pete Hughes)

The site is undergoing enormous change and many common saltmarsh plants (e.g. Annual Sea-blite *Sueda maritima*, Glasswort *Salicornia europaea* and Orache *Atriplex* spp.) are colonising the new intertidal areas, with considerable developments from year to year (see Figs. 4.3 and 4.4). This is likely to continue as the site changes further, and the old vegetation continues to disappear. The precise boundaries of the saltmarsh and nearby grasslands in particular are evolving in response to the changes to the former barrier beach.

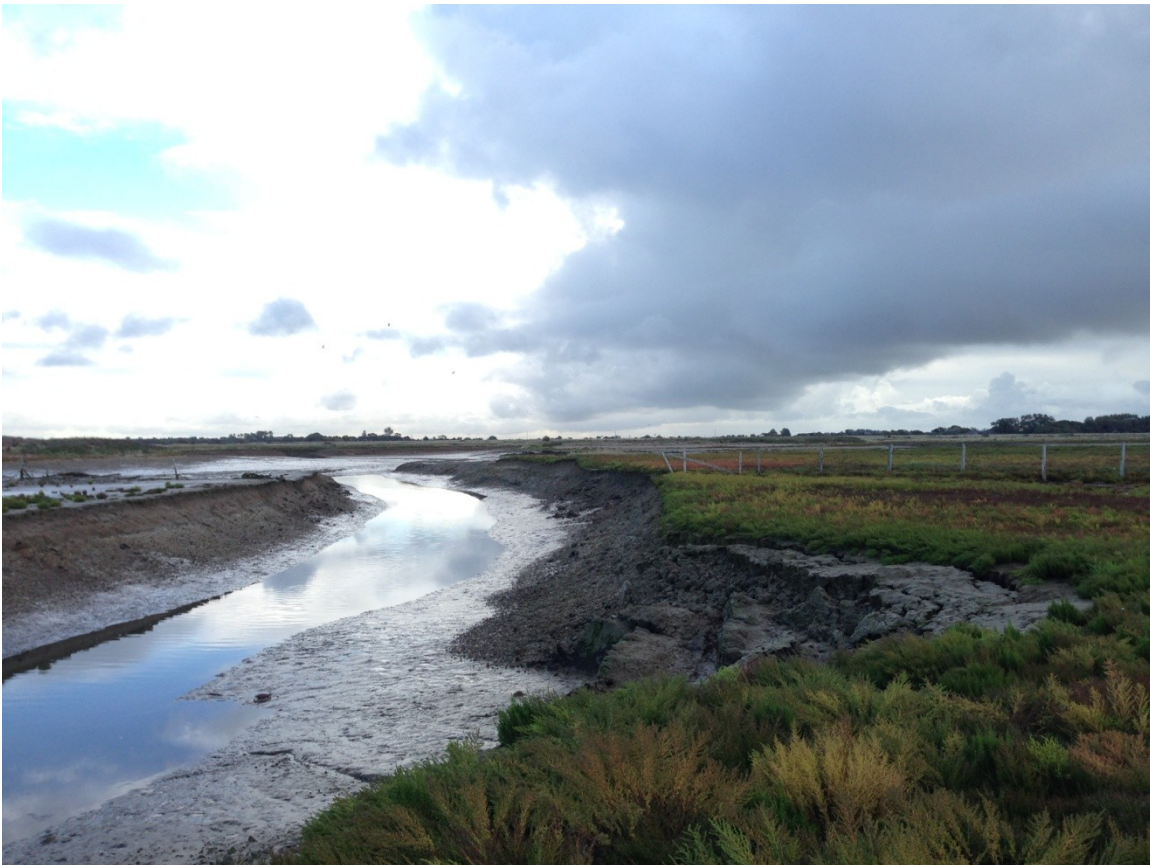
Figure 4.4: Developing saltmarsh eight months later, 18 September 2015 (Pete Hughes)

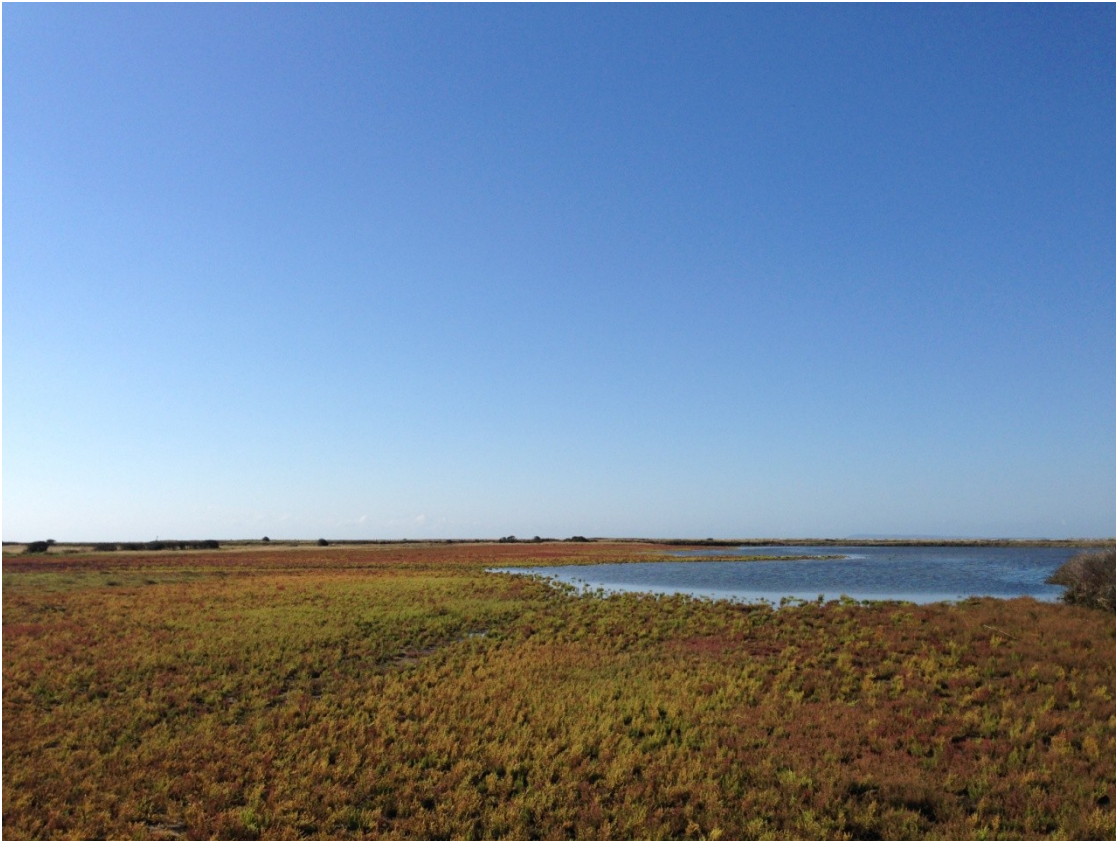
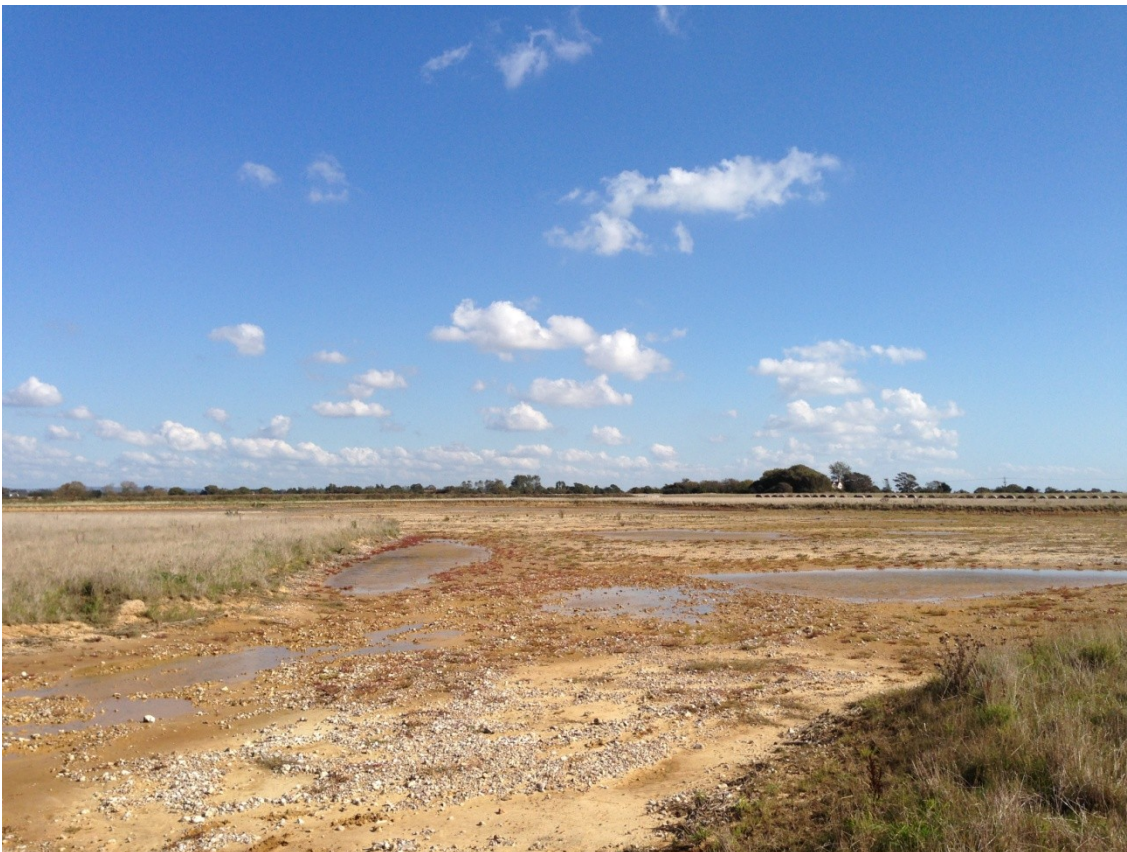
Figure 4.5: Developing saltmarsh on former arable field 27 September 2015 (Pete Hughes)

Figure 4.6: Developing vegetation, borrow pit 6, 27 September 2015

The old arable fields (with high levels of nutrients) have been colonised much more fully than the excavated borrow pits (with very low nutrients) (Figs. 4.5 and 4.6). This is to be expected and creates a level of variation across the site which is beneficial to a wide range of wildlife.

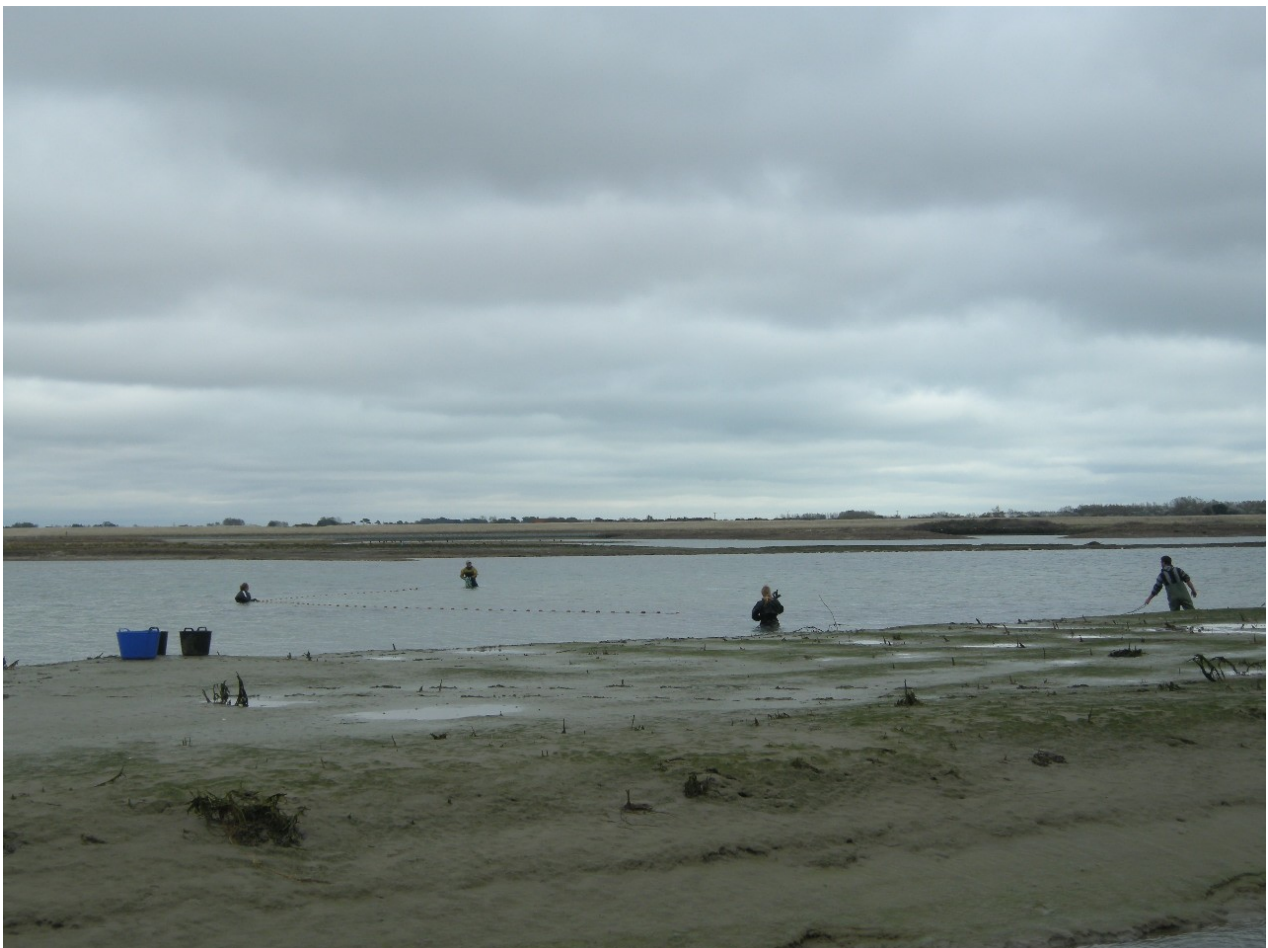
Figure 5.3: Seine netting, 14 October 2014

Surveys were carried out twice in 2014 (July and October) and three times in 2015 (June, July and Sept) using Seine nets (which are drag nets with weights along their lower edge) (Figs. 5.3 and 5.4) and Fyke nets (which are cone-shaped nets that sit underwater allowing fish to swim into them), plus some hand netting of fish fry in the 2015 surveys.

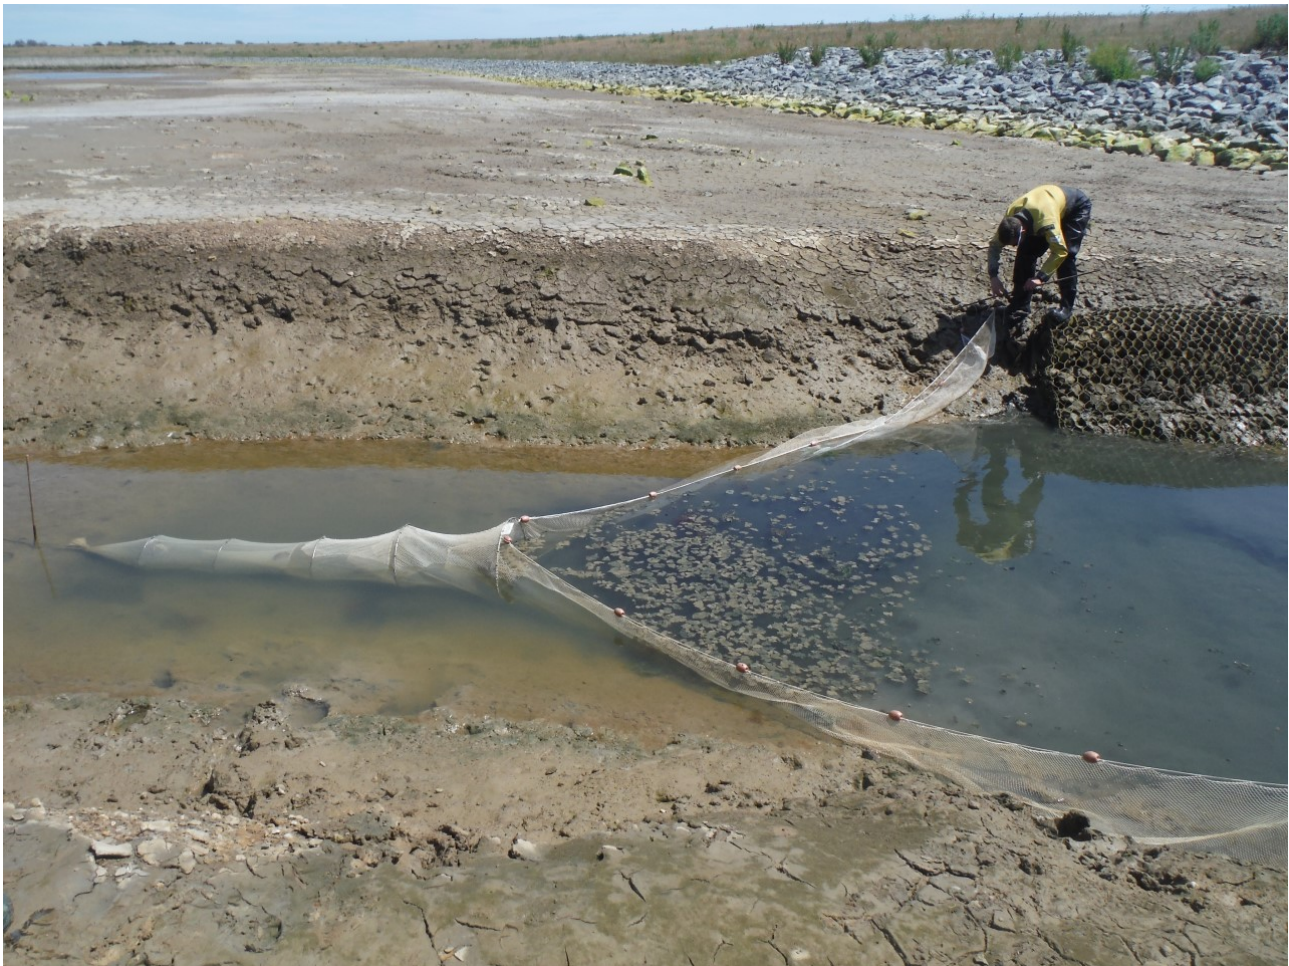
Figure 5.4: Fyke netting at Medmerry (IFCA)

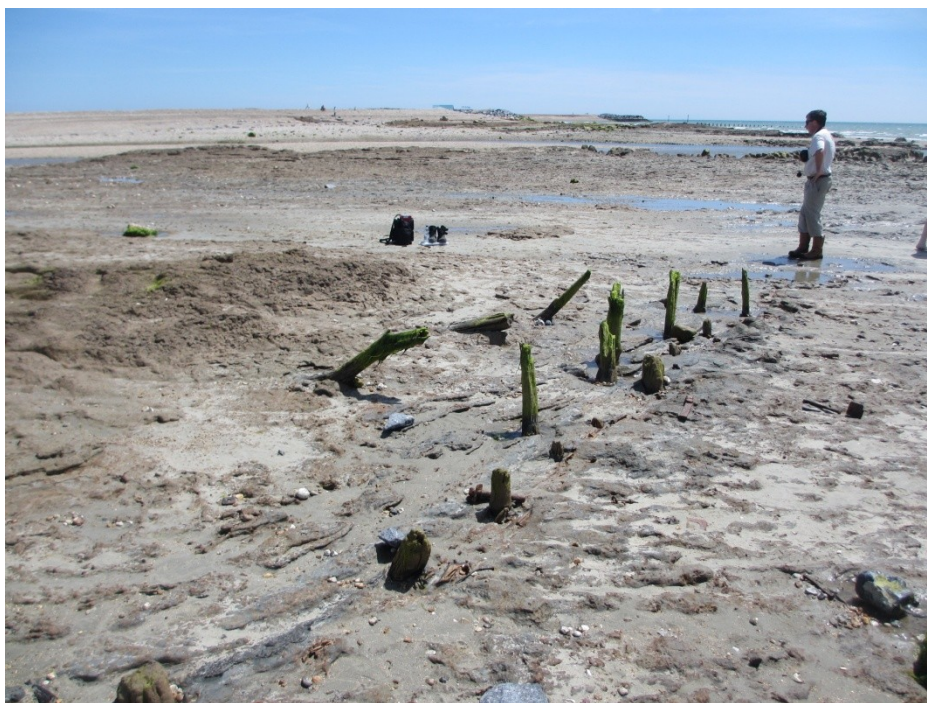
Figure 6.1: Probable medieval fish trap

4. **Late Saxon and medieval wooden structures.** A wattle fence cuts across one of the burnt mounds and is probably a continuation of similar structures in the ASE excavations, dating to the Late Saxon to 14th-15th centuries. A fish basket or the base of an eel trap has also been recovered, dated to 1449-1635 cal AD. Two large braced linear timber structures with associated wickerwork have also been planned and recorded. They are probably fish traps. 14C dates are awaited.

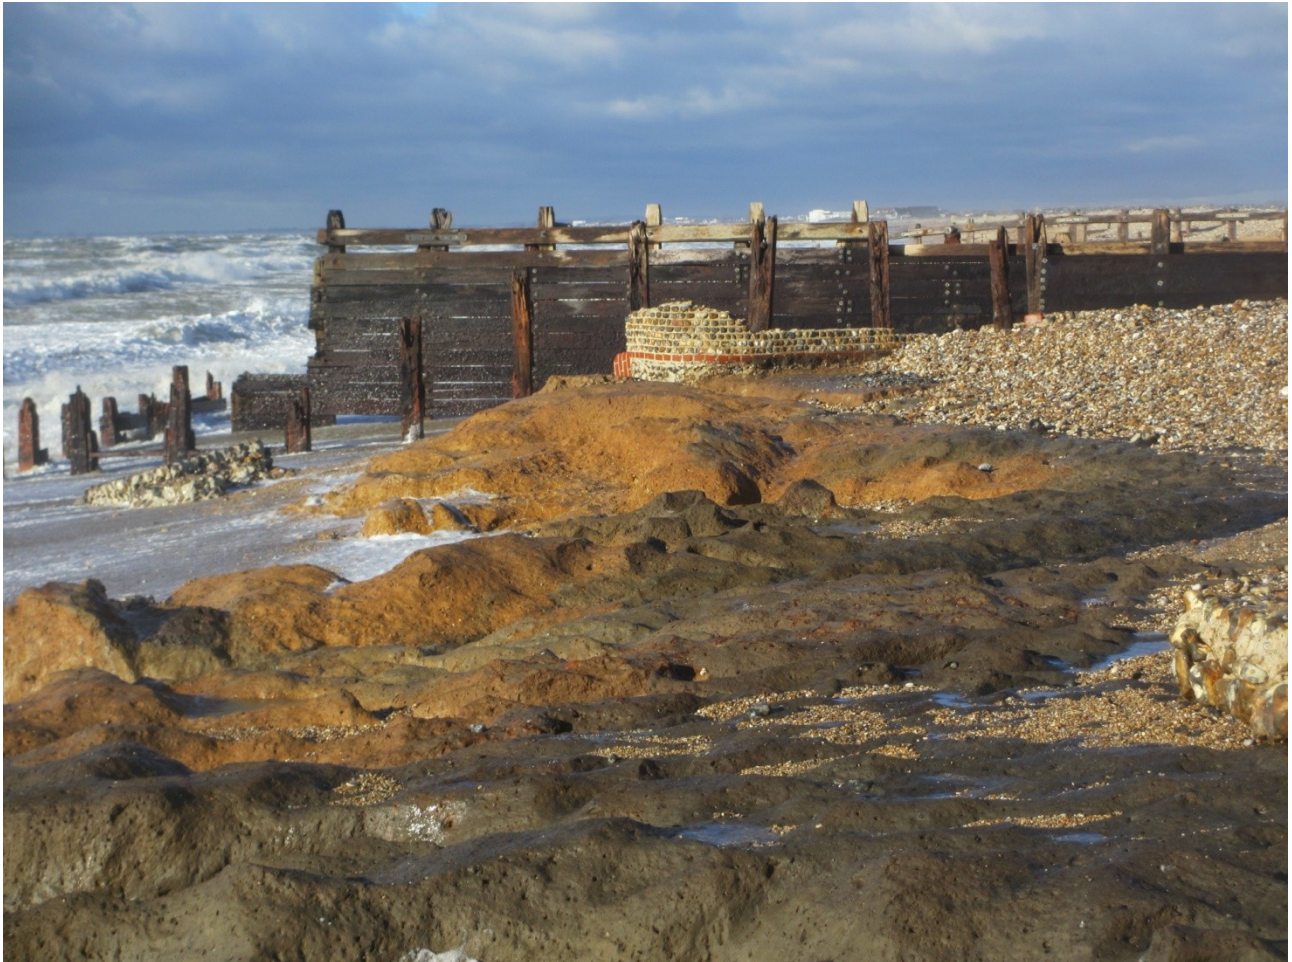
Figure 6.2: Flint and brick walls of Thorney Farm, visible just in front of wooden groyne

6. **19th century structures** - Thorney Farm. In January to April 2016 flint and brick walls of part of this farm were exposed and then destroyed by erosion, leaving scant time for recording. The farm was certainly there by 1810, appearing on a map of that date. A map regression shows that it survived until the late 19th century and then was over-ridden by the shingle bank moving inland. By 1914 the only buildings left were “two dilapidated huts inhabited by four or five men who made

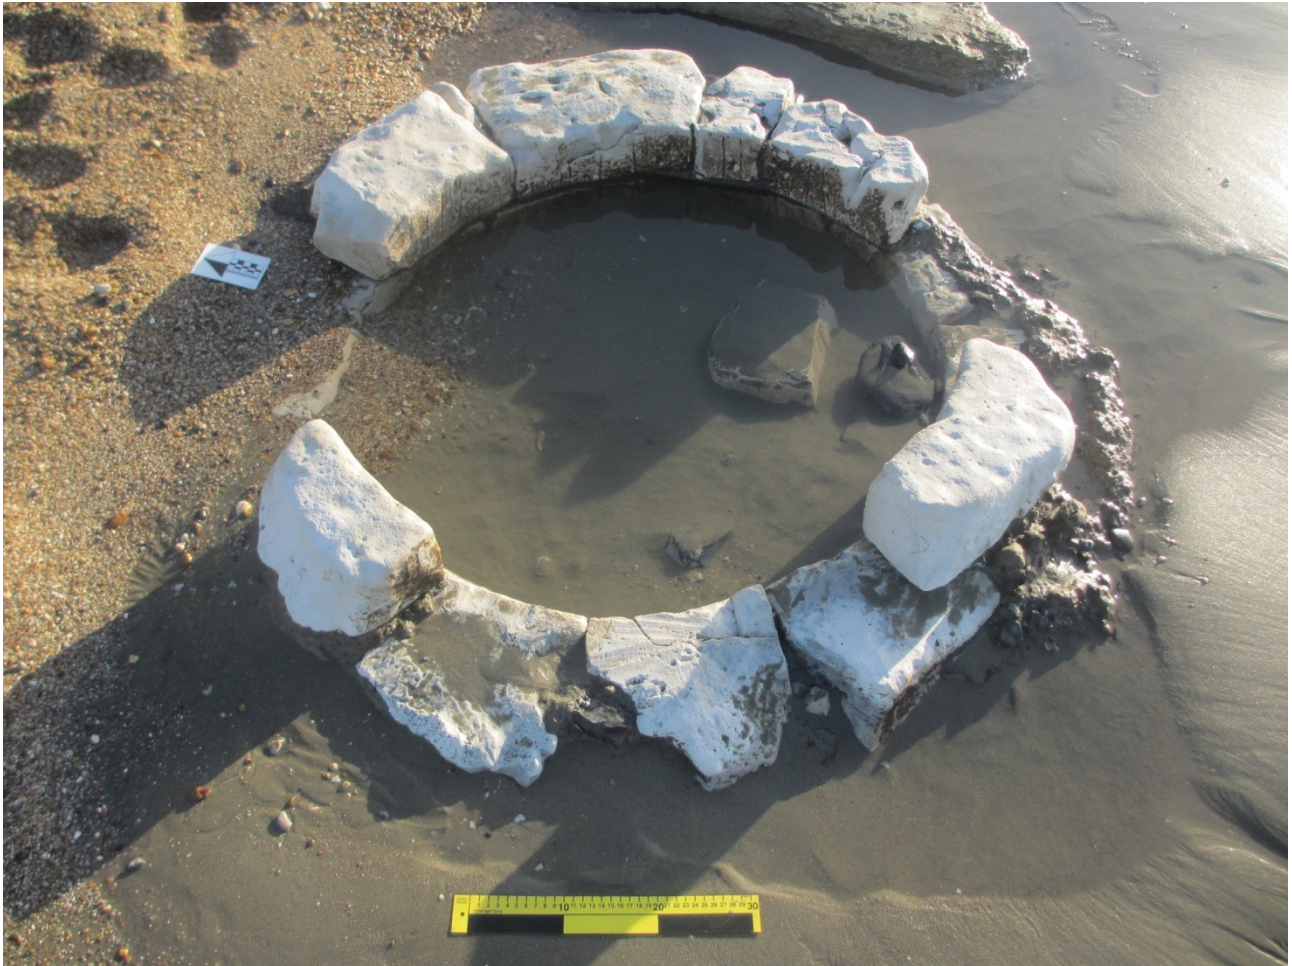
Figure 6.3: Remains of chalk lined well at Thorney Farm
