The Coastguard Station (MBW 34) at Medmerry, near Selsey, West Sussex

Peter Murphy with contributions from
Hugh Fiske, Mike Kallaway, James Kenny and Peter King
January 2024

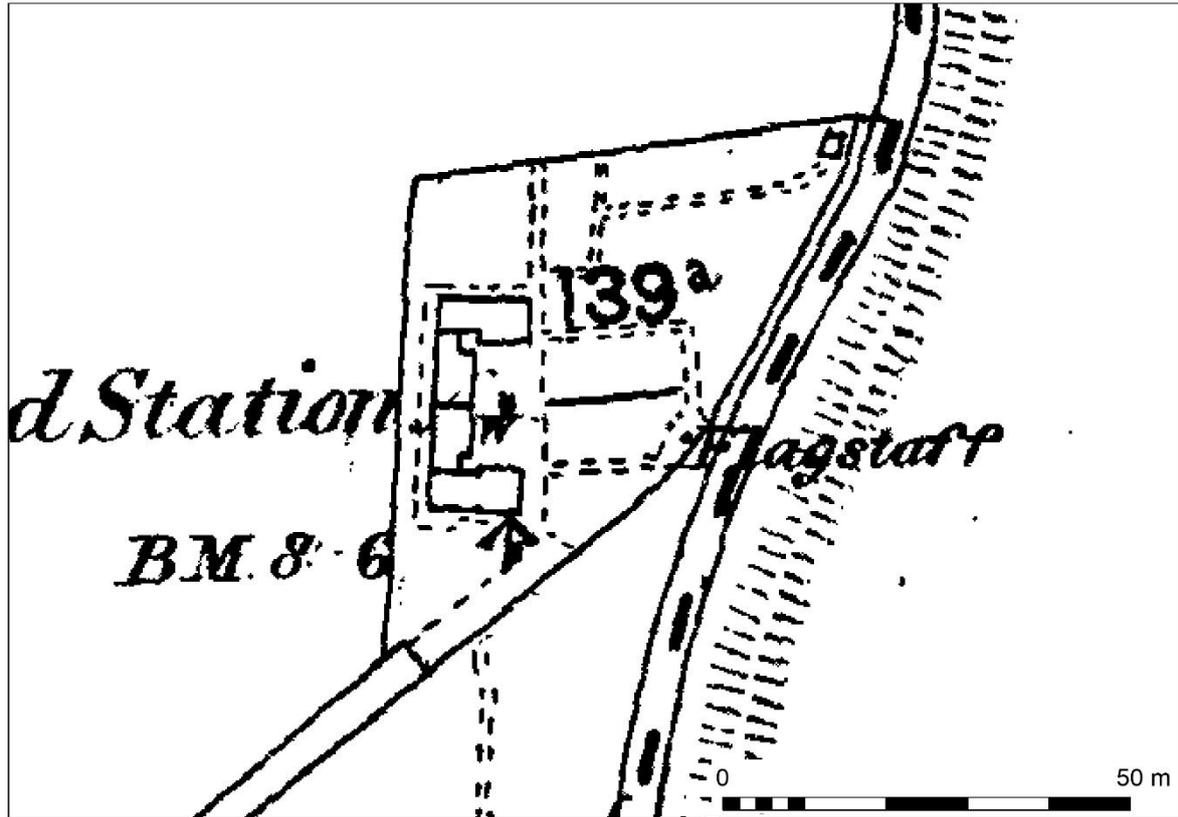
The plan enlarged by Mike Kallaway from the OS 25 inch map of 1875 (Fig 3) indicates the building's overall form. Only the southern half of the structure was recorded in detail, but the 19th century map shows that the structure was essentially symmetrical. The parts of the building recorded in detail comprised the southern wing and part of the central linking range. Locations were SZ 83144 94518 (SE corner of south wing) and SZ 83132 94518 (SW corner).

Fig 3 Enlarged portion of OS 25 inch 1875 map showing the Coastguard Station and drainage channel running alongside to the East.

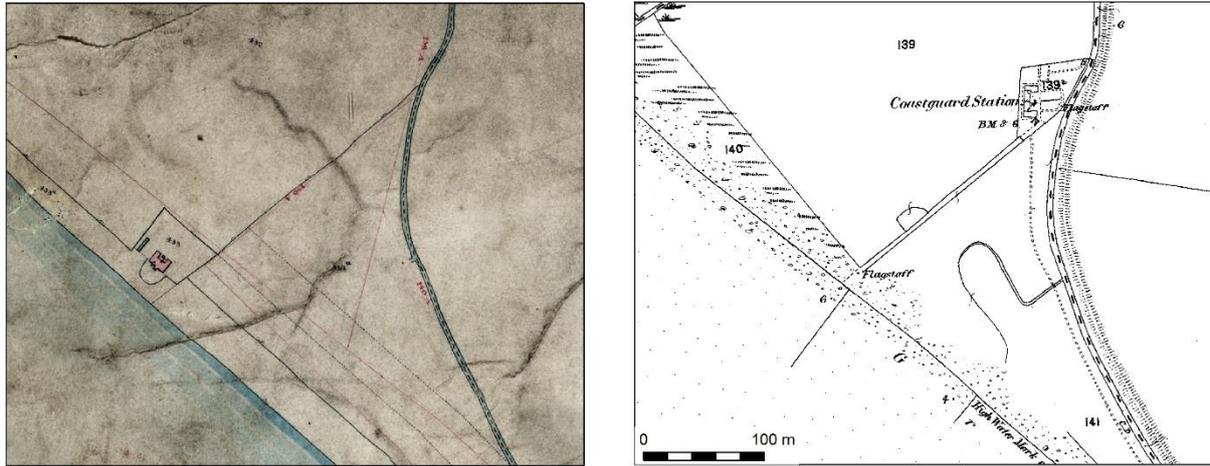
Fig 11. The Preventive Station shown on the Selsey Tithe Award map of 1839 and the new Coastguard Station on the OS 25" map of 1875

The Ordnance Survey first edition 25-inch map of 1875 (Fig. 11) shows the coastline having receded by about 43m since 1839 and the site of the old Preventive Station marked by a solitary flagstaff. A new Coastguard Station, shown about 200m inland, is clearly the same as the building recorded in 2020-22, but to confuse matters the West Street station is now shown as Thorney Coastguard Station. In the 1861 census the Description of Enumeration District for Selsey refers to 'New and Old Thorney Stations', and it seems likely that these are the new one and the old one at West Street. The 1871 census refers to the Coast Guard Station and the Old Coast Guard Station, but the 1881 census refers to a single Thorney Coast Guard Station, the 'new' station (the one we have recorded) having presumably gone by then. It is not shown on the OS second edition 25-inch map of 1898, by which time the one at West Street had also been lost to coastal erosion (at least 39m between 1875 and 1898) and replaced further inland by a Watch House and a row of cottages, still called Thorney Coastguard Station.

It seems likely, therefore, that the Preventive Station (Fig 11 :433) was built between 1809 and 1822, converted into a coastguard station and lost to coastal erosion by 1861. The new coastguard station (the one we have recorded) was built between 1839 and 1861, was disused by 1881 and was presumably demolished at about the same time.
